# Fast repair turns the tide for shower floor manufacturer

**What:** Repair resin-transfer moulding tool

**How:** D523 low-pressure cold spray system with nickel

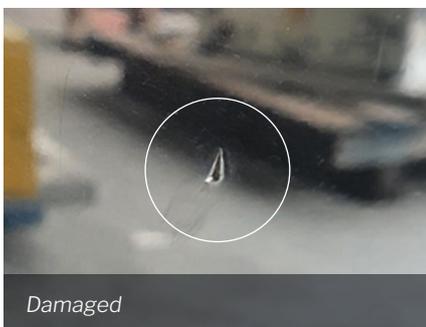
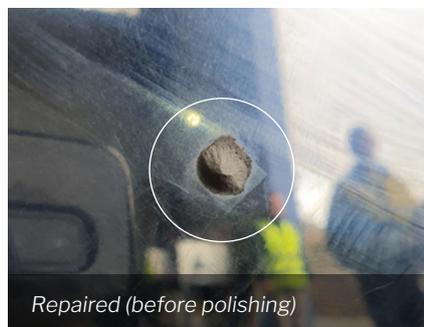
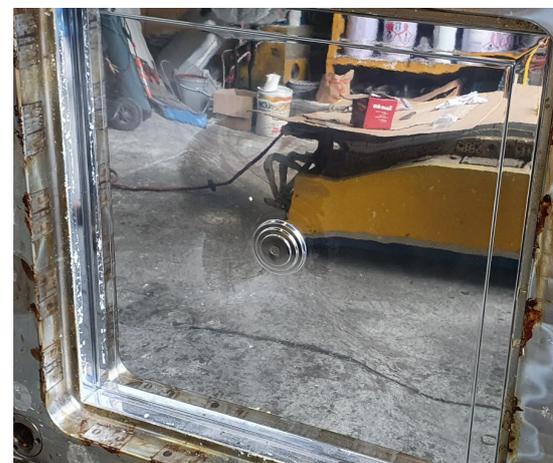
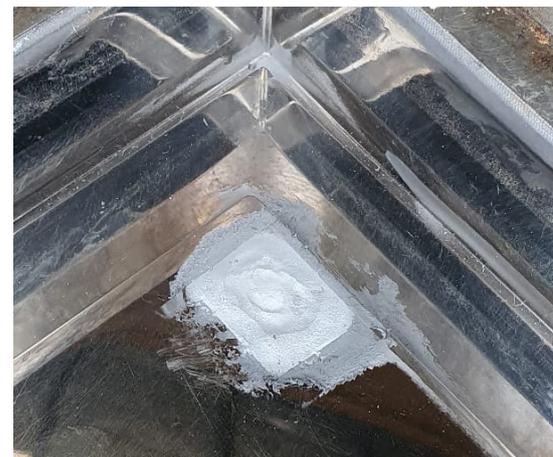
When a piece of metal debris was left on the base of a resin-transfer moulding (RTM) tool used to create shower floors, it left a hole that would fill with resin and leave behind a raised imperfection.

Rather than send the tool overseas, we proposed bringing the portable D523 low-pressure cold spray system on site to fix the damage.

It took just five minutes to fill the hole with nickel – before removing the excess and hand-polishing the tool.
