CASE STUDY

Low-pressure cold spray speeds up motor bearing housing repair

When engineering shop Mallee Machining Services was asked to repair a motor bearing housing suffering from wear, a lengthy and expensive sleeving process seemed to be the only option – until Titomic’s D523 low-pressure cold spray system turned things around.

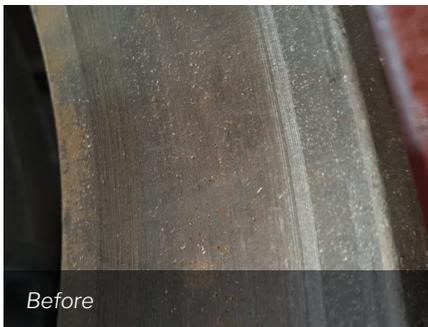
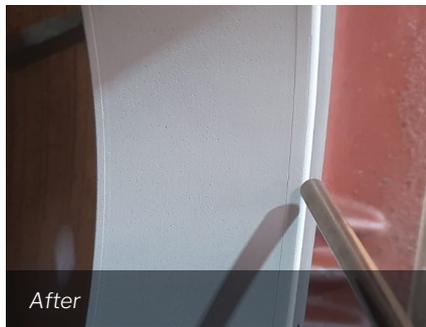
Using the D523 low-pressure cold spray system, we elected to resurface the cast-iron housing by applying a hard-wearing layer of nickel and filling the pitting and abrasion. Our team worked in tandem with Mallee, creating a jig to evenly coat the bearing and using rotational and lateral movement to apply the coating.

Since the D523 can spray metal in seconds, it took just one-and-a-half hours, 500 grams of nickel, and a mere \$120 in material costs to bring the bearing housing back to working condition.

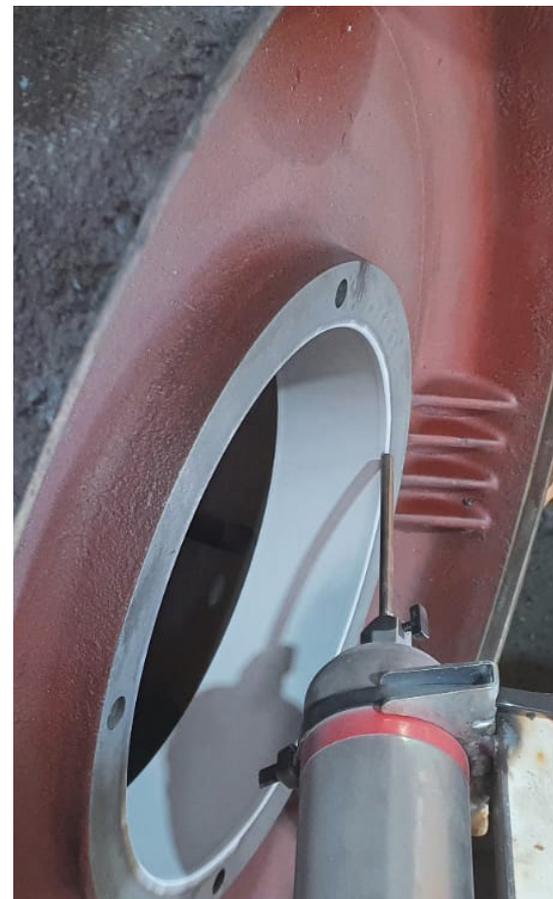
What: Resurface and repair electrical motor bearing housing

How: D523 low-pressure cold spray system with nickel

Outcome: Bearing housing repaired in 1.5 hours for \$120 in material – sleeving would have taken at least double the time, and cost.
