CASE STUDY

Alloy wheel repair an all-round success with cold spray

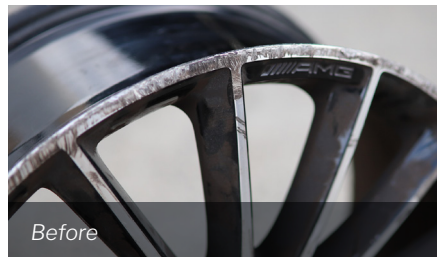
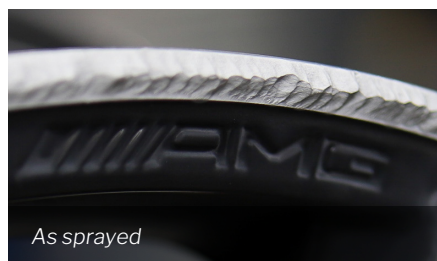
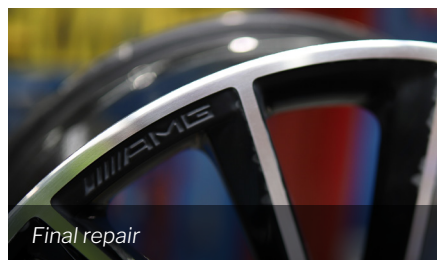
Before spraying the metal, the D523’s grit-blasting feature was used to remove excess edges and clean the surface for enhanced adhesion of the metal powder.

The alloy wheel was then machined back to OEM specifications with the damage quickly and effectively repaired. This process was remarkably faster, easier, and safer than welding.

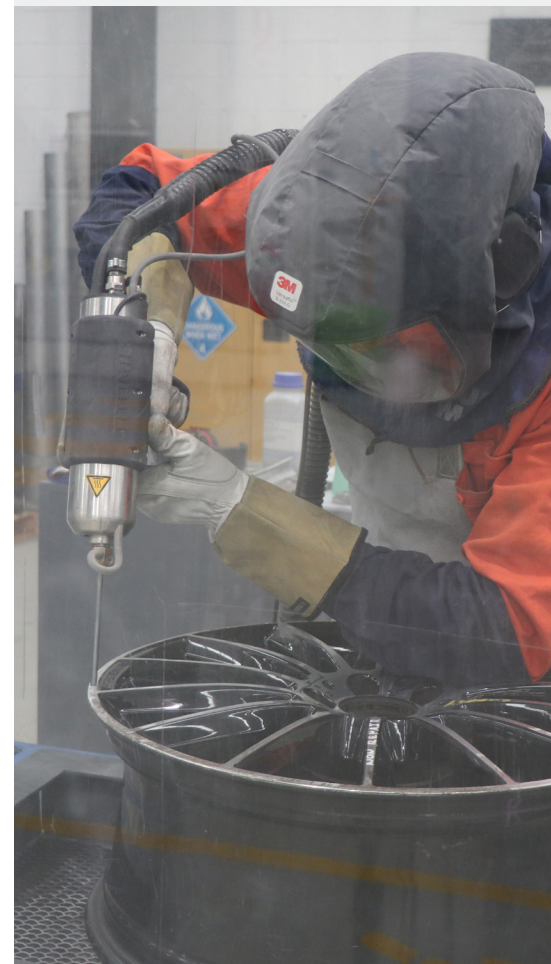
What: Repair AMG SUV alloy wheel

How: D523 low-pressure cold spray system with Aluminium Alloy K-10-01

Outcome: Wheel repaired in significantly less time, with less risk of damage
