## CASE STUDY

# Fuel tank repair keeps mining trucks moving

To recondition or repair large fuel tanks, they often need to be taken off a vehicle, drained, made explosion proof, then welded. With cold spray, you can repair fuel tanks and parts in-situ.

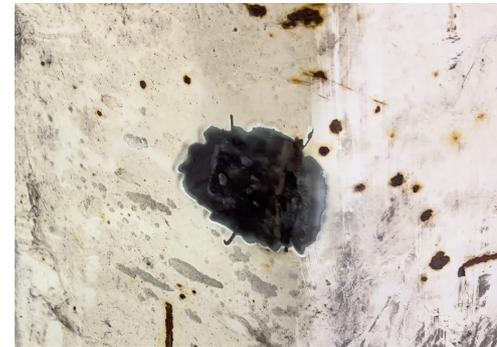
Filled & polished surface

Rather than detach and drain the 5000 litre fuel tank, Brauntell 'veed out' the crack in the tank, then used the portable, hand held D523 unit to fill the divot with nickel. It took just ten minutes to fill the hole with nickel, before grinding back with an angle grinder, fully restoring the crack and returning the tank to a safe state.

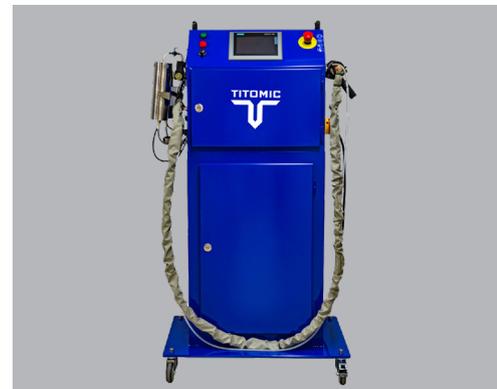
The portable D523 cold spray system

**How:** D523 low-pressure cold spray system with nickel
