CASE STUDY

Quick corrosion repair on wind turbine heat exchanger

What: Wind turbine heat exchanger repair

Where: Fire Island Wind, Alaska

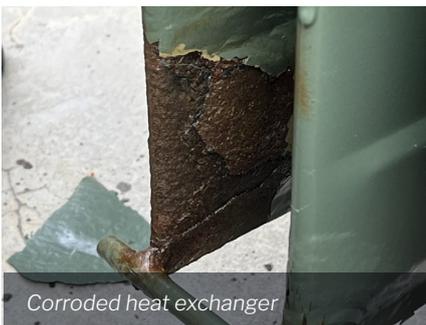
Corroded heat exchanger

Instead, the D523 was used to blast away the corroded material and then to coat the affected areas with less than \$500 worth of aluminium. Over time, the aluminium forms an oxide layer, protecting the underlying surface from further corrosion for years to come.

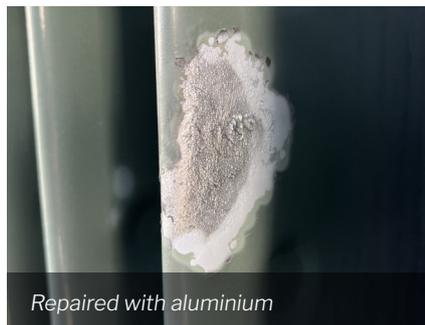
Repaired with aluminium
